Manhole Inspection Summary

Manhole # S45I2_032MH

Insp Date: **11/12/08 3:15 PM**

Location Address: **1405 Church St.**

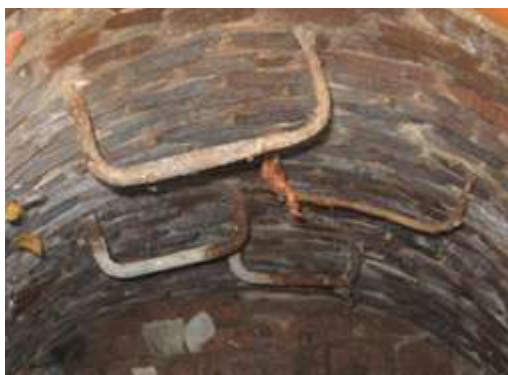
Steps Count: **4** Missing: **0** ☒ **Corroded**

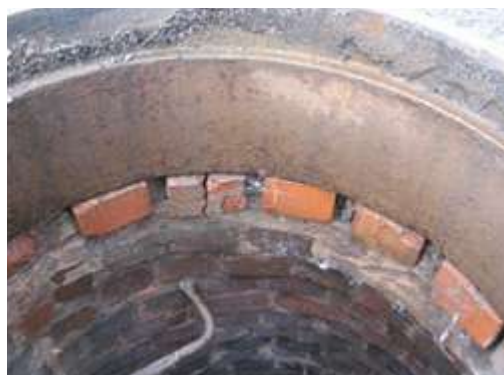
Defect 1

Condition: ☐ Sound ☒ **Cracked** ☐ Root Intrusion ☒ **Loose Brick** ☐ Deteriorated

Infiltration: ☐ None ☒ **Joint** ☐ Cracks ☐ Mortar ☐ Roots ☐ Wall

Frame-Chimney joint

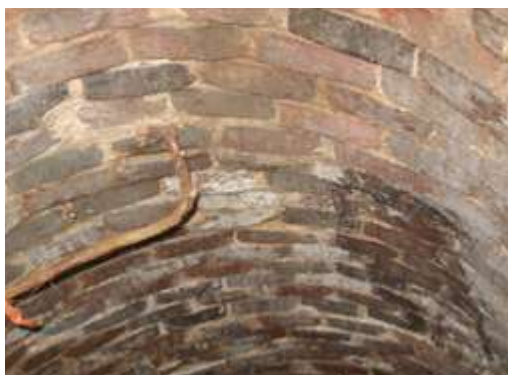
Defect 2

Infiltration: ☐ None ☐ Joint ☐ Cracks ☐ Mortar ☐ Roots ☒ **Wall**

Infiltration

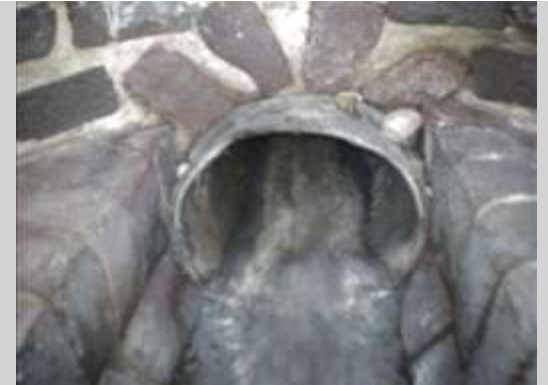
12 O'Clock Outflow

10 in. Circular Gravity Sewer
Pipe Out @ 12 O'Clock

Pipe Height: **9.6** (in.) Rod and Bar (Angled)
Pipe Material: **Clay** ☐ Pipe Lined
Invert Depth: **8.40** (ft.) Flow Characteristics: **Fast**
Deposits: ☒ None ☐ Mud ☐ Sludge ☐ Debris ☐ Grease
Silt Depth: (in.) Deposits Extent:
Infiltration: **None** Pipe Seal Cond: **Sound**

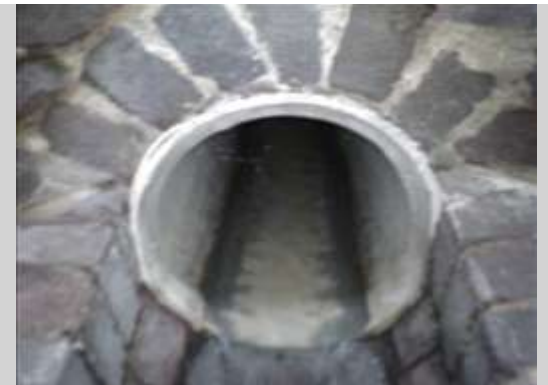
6 O'Clock Inflow

10 in. Circular Gravity Sewer
Pipe In @ 6 O'Clock

Pipe Height: **9.6** (in.) Rod and Bar (Angled)
Pipe Material: **Clay** ☐ Pipe Lined
Invert Depth: **8.10** (ft.) Flow Characteristics: **Fast**
Deposits: ☒ None ☐ Mud ☐ Sludge ☐ Debris ☐ Grease
Silt Depth: (in.) Deposits Extent:
Infiltration: **None** Pipe Seal Cond: **Sound**
